DE2 Power Failure

Diagnostic and Correction

DE2 Capacitor Failure:

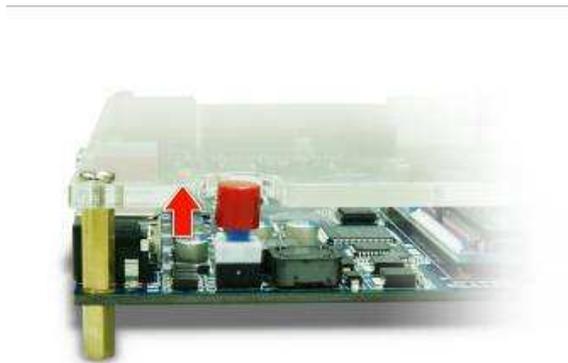
Figure 1

- Inspect the Capacitor labeled TC3 :
 1. The top appearance of TC3 capacitor may appear dark brown.
 2. The base (black plastic) of TC3 capacitor is separated from TC3 capacitor.
 3. It is also possible that no visible signs will be evident.
- Using a multi meter :
 1. Release the red switch to POWER OFF state (out) as shown in Figure 1. And turn DE2 over to the back side as shown in Figure 2.

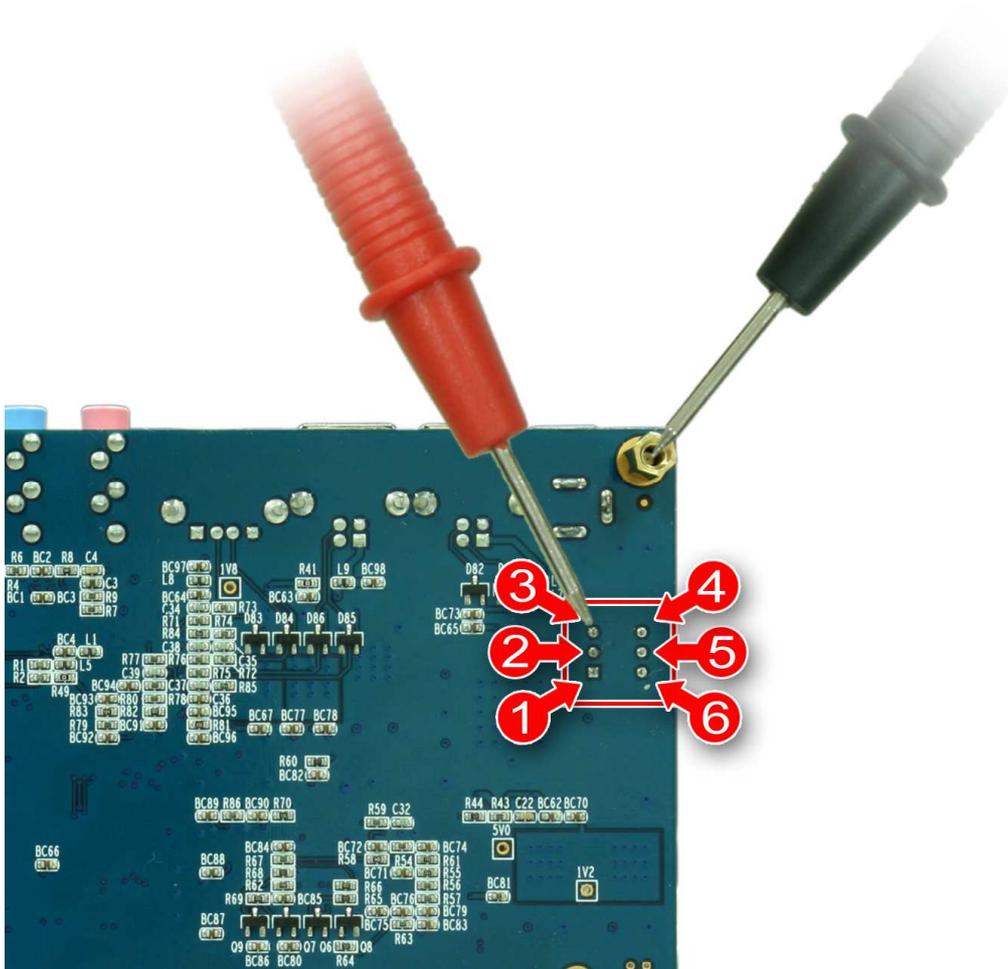
Figure 3

2. Set the multi-meter to measure Ohms and put the black probe on the copper standoff as shown in Figure 3. (this is the board ground) Then measure the pin 3 or pin 6. (Pin 3 and Pin 6 are electrical equivalent points)
 - You can determine if TC3 is damaged if either Pin 3 or Pin 6 is shorted to ground (Please refer to Table 1).

Pin 3 or Pin 6 To Ground	Assertion Result
0 (short)	Damaged TC3
∞ (open)	TC3 OK

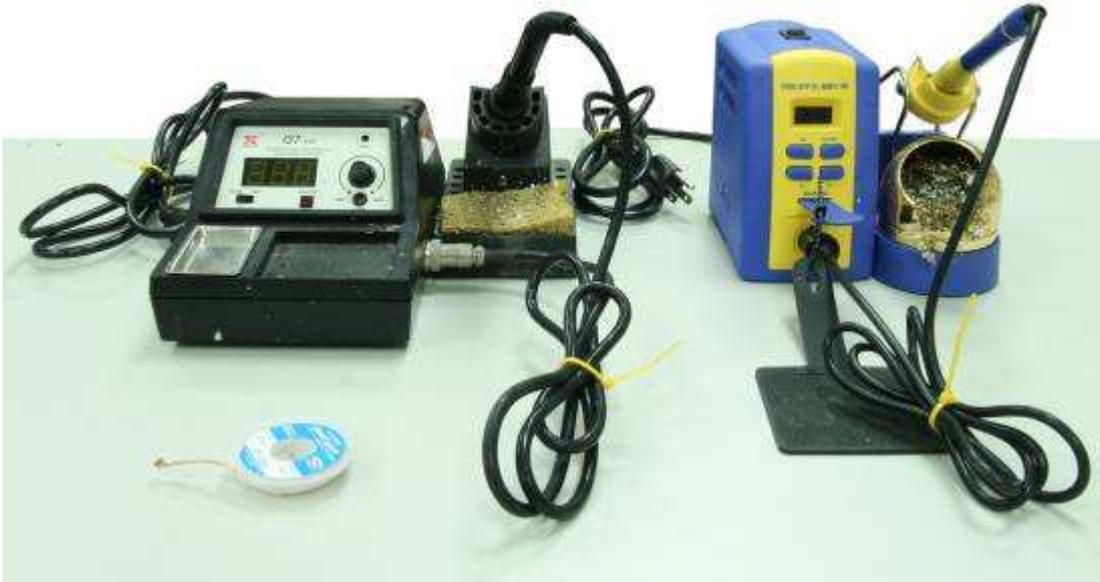
- Prepare the following tool sets as shown in Figure 5 :
 1. Two soldering irons. Working temperature is 400°C (for lead-free solder)
 2. A tape of de-soldering wick.

Figure 5. Required tools
